Number: TIC2017-0001

Title: Code 31 Inspection Sheet **Product Category:** Gas Furnaces

35-inch tall Condensing Gas Furnaces

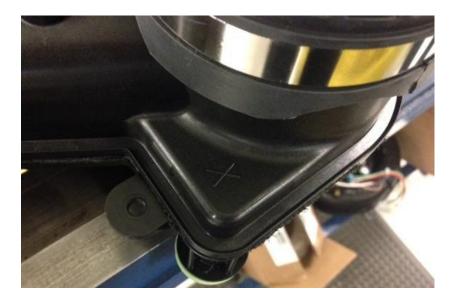
- Drain any water collected in the inducer assembly
 a. Dry out the inducer housing by blowing air from a shop vac through it
- 2. Verify there is no inducer outlet restrictor (remove vent elbow to verify) installed a. Except 40,000 BTUH models with less than 10 ft. of TEL
- 3. Verify inducer has an "X" embossed on the housing, just below and to the right of the vent elbow.

The inducer with an "X" embossed on it has a larger internal port. It is not necessary to re-drill the port on this inducer. See DSB 14-0004

- a. If the inducer does not have an "X" embossed on it:
 - 1. Refer to DSB 14-0002
- b. Drill out the housing pressure switch port with a 5/32-in. and 3/16-in. drill bit
- c. Be sure to spin the drill bit in the port to prevent rifling of the port
- 5. Clean out any debris or PVC shavings in the drain stubs on the back of the inducer
- 6. Remove the orange gasket from the inducer assembly.
 - a. Re-install it in the inducer inlet without pushing the gasket down into the pocket
 - b. Re-install the inducer assembly
- 7. Verify correct inducer inlet choke is installed in the inducer inlet

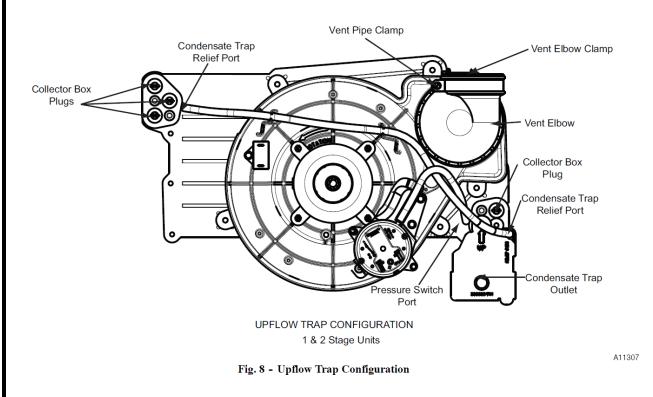
Verify Pressure Switch/Relief Tube connections

- 1. Relief Tube (colored hose) from relief port on trap to opposite corner of Collector Box
- 2. Inducer Housing Pressure Switch Tube (square tube) from rear pressure switch to port on inducer housing
- 3. Collector Box Pressure Switch Tube from front pressure switch to port on Collector Box next to the trap
