TECHNICAL INFORMATION COMMUNICATION

Number: TIC2014-0012

Title: Incorrect Field Wiring of AOC Board

Product Category: Air Conditioners/Heat Pumps

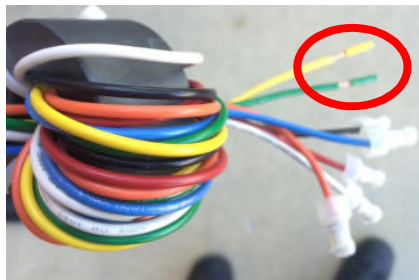
- Only two wires are required for communication between indoor unit and outdoor unit. White (C-common) connection is optional and only used if communication issues are present.
- Those two wires are green (A) and yellow (B) on the low voltage choke harness (LVCH). These wires are stripped at the field connection end as shown in Figure 1 (circled in red).
- The factory already provided the green and yellow connections to the green ABCD plug as shown in figure 2.
- **Caution: 24 VAC leads should not be connected to these wires.**
- If 24 VAC is applied to the ABC terminals, damage to the AOC board may occur and AOC will not be able to communicate with the wall control. If damaged, AOC board will require field replacement.
