TECHNICAL INFORMATION COMMUNICATION

Number: TIC2021-0004

Title: Modulating Inducer Assembly Power Connector Plug Position

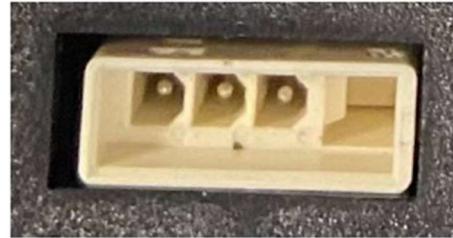
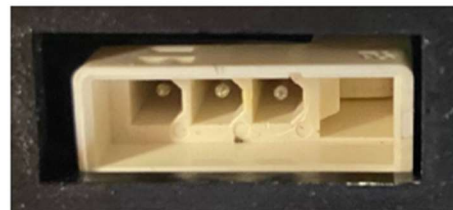
Investigation of modulating inducer assemblies that had been returned for noise has identified a potential for the power connector inside the assembly housing to be pushed under the edge of the assembly which could interfere with proper harness connection. This interference results in a potential of noisy or no operation of the inducer motor.

It is believed this incorrect position may be a result of movement during shipping or unit handling and not typical of operational movement.

1. In the event of inducer operational noise or no run condition review the position of the motor power connector. If the connector is out of position partially under the housing edge as shown in picture above (B) the connector position can be corrected in the field.
 - a. Disconnect from the incorrectly positioned connector and manually manipulate the connector out from under the edge of the housing to represent the correct position shown above (A). Reconnect the connector and verify proper operation.

1. Redesign of the motor power connector mold will prevent the connector from being able to move under the housing edge and interfering with the harness connection. This will be a running change and seamless to the field.
