TECHNICAL INFORMATION COMMUNICATION

Number: TIC2021-0004

Title: Modulating Inducer Assembly Power Connector Plug Position

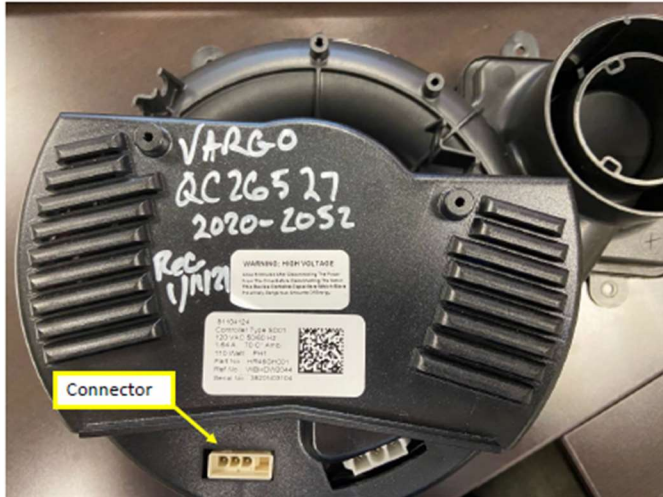
Investigation of modulating inducer assemblies that had been returned for noise has identified a potential for the power connector inside the assembly housing to be pushed under the edge of the assembly which could interfere with proper harness connection. This interference results in a potential of noisy or no operation of the inducer motor.

It is believed this incorrect position may be a result of movement during shipping or unit handling and not typical of operational movement.

1. In the event of inducer operational noise or no run condition review the position of the motor power connector. If the connector is out of position partially under the housing edge as shown in picture above (B) the connector position can be corrected in the field.
 - a. Disconnect from the incorrectly positioned connector and manually manipulate the connector out from under the edge of the housing to represent the correct position shown above (A). Reconnect the connector and verify proper operation.
