TECHNICAL INFORMATION COMMUNICATION

Number: TIC2017-0005

Title: Base Pan Short Fork Protection

Product Category: Small Rooftop Units Chassis 1 & 2, 3-6 ton

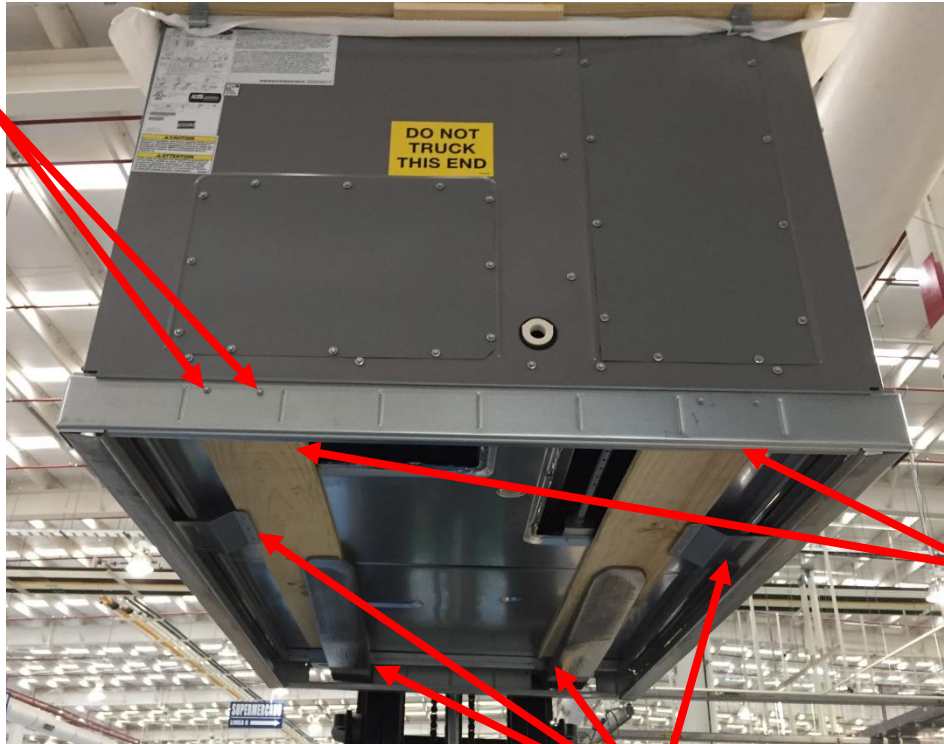
(Figure 1) – Brackets and Mounting Screws

Bracket
Mounting
Screws
(Typical)

Bracket
Locations
(Hidden)

Bracket Locations

The two pieces of wood must be removed before installation. For each piece of wood, there are three metal support brackets, each secured to the baserail with two screws to secure the wood in place. Remove the 12 mounting screws as shown in (Figure 1). Discard the wood and brackets. Failure to remove the wood and brackets will interfere with the ductwork installation. When forking from the side, ensure the forks remain level until full engagement before tilting. Failure to do so could result in the forks going between the wood and base.
